RESEARCH ARTICLE

Seismic damage assessment based on site observation following the Düzce (Gölyaka) earthquake ($M_w = 5.9$, November 23, 2022)

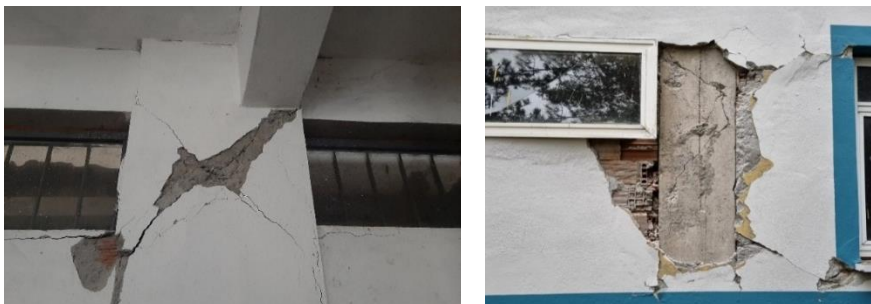
In a significant part of the existing buildings, the gaps left between the infill walls, the windows left on the ground level of the buildings for lighting and ventilation, half-walls in the basement and ground floors, etc. conditions cause the formation of short colons (Fig. 13). Short columns have high stiffness and low ductility. Therefore, this situation causes the short columns to be damaged by shear failure by losing strength.

Fig. 13. Damages caused by short column

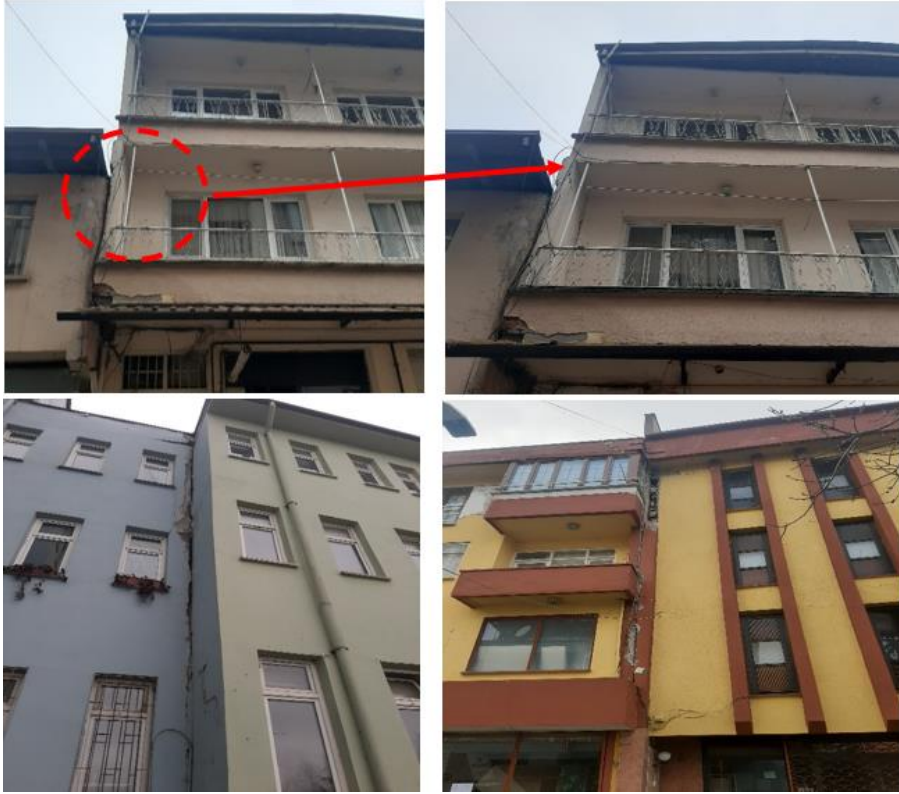
In the event of an earthquake, it is necessary to eliminate the effects of the horizontal movements of the adjacent buildings on each other and to apply a gap distance that allows the buildings to work independently from each other in all directions during the earthquake. In cases where the gap distance is not sufficient and the floor levels of the buildings are different, pounding damages can occur during the earthquake (Fig. 14). To prevent the formation of such damages, gap distances should be left between adjacent buildings in accordance with the regulations.

Fig. 14. Damages caused by the inadequate safe distance between adjacent buildings

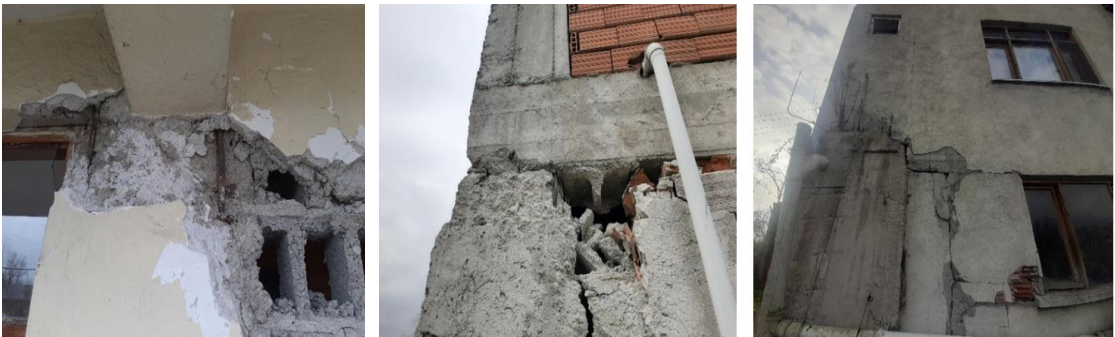
Fig. 15. Damages caused by column-beam connection failures

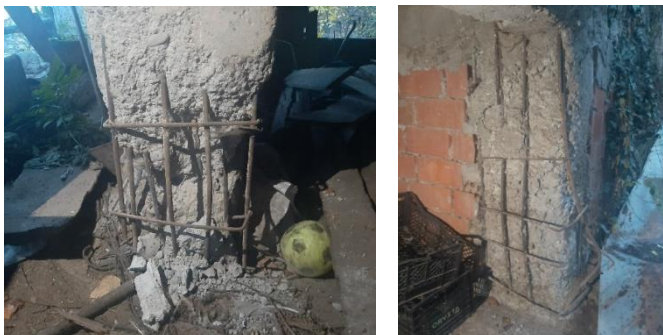
Column-beam connection areas are exposed to great stresses under the effect of earthquakes. Shear forces and principal tensile stresses occurring in the connection areas cause cracks and dispersion of the concrete. Structural damage in the RC buildings because of column-beam connection failures was detected in the site observations. Inadequate use of transverse ties was confirmed in the beam-column connection areas (Fig. 15). Also, the existence of insufficient lap splice, which is the length of the two reinforcements in the common area, affects the seismic performance of RC structures negatively (Fig. 16).

Fig. 16. Observed damages due to insufficient lap splice

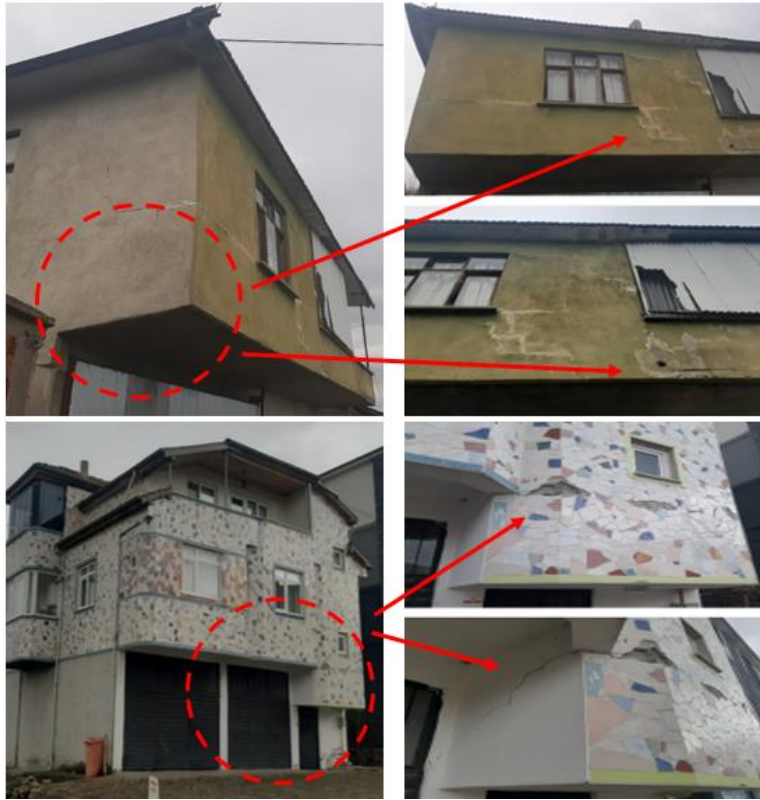
Because of the limited construction areas in city centers, cantilevers above the ground level are usually often preferred. But, in the building floor plans, heavy cantilevers are formed when the dimensions of the cantilever parts in two perpendicular directions are each greater than 20% of the total plan dimensions of that floor in the same directions [31]. Heavy cantilever formation causes the vertical center of mass of the building to shift and increases the earthquake effect on the building (Fig. 17).

Fig. 17. Damages caused by the long and heavy cantilevers

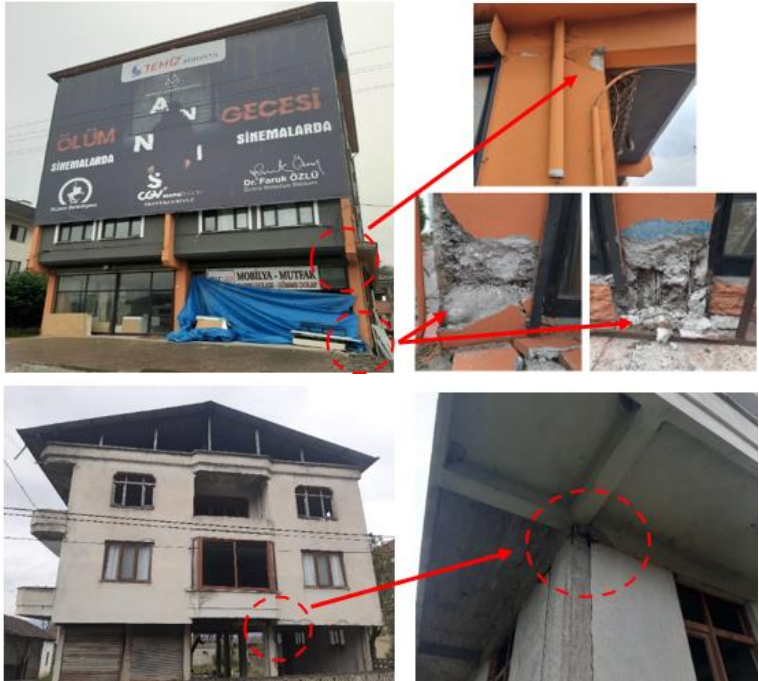
On the other hand, soft story formation is a common occurrence on ground floors in residential buildings. The soft floor, which is formed as a result of the high entrance floors of the building and the lack of infill walls, causes more horizontal displacement of the lower floors during the earthquake and severe damage to the load-bearing system (Fig 18).

Fig. 18. Damages caused by the soft story

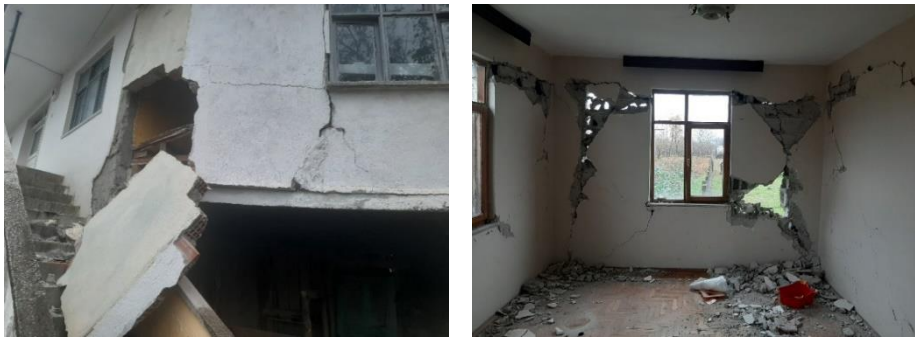
Weak infill wall damages occur more quickly in walls built with low-strength materials. X-shaped cracks appear on the infill walls and spills are observed on the plaster (Fig. 19).

Fig. 19. Weak infill wall damages

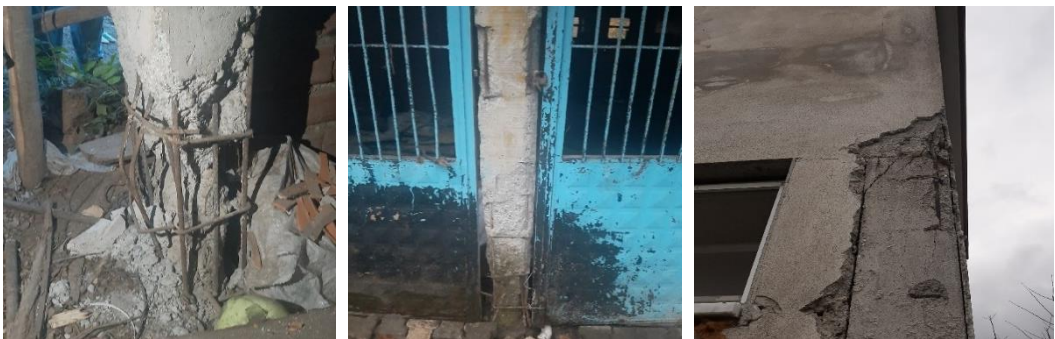
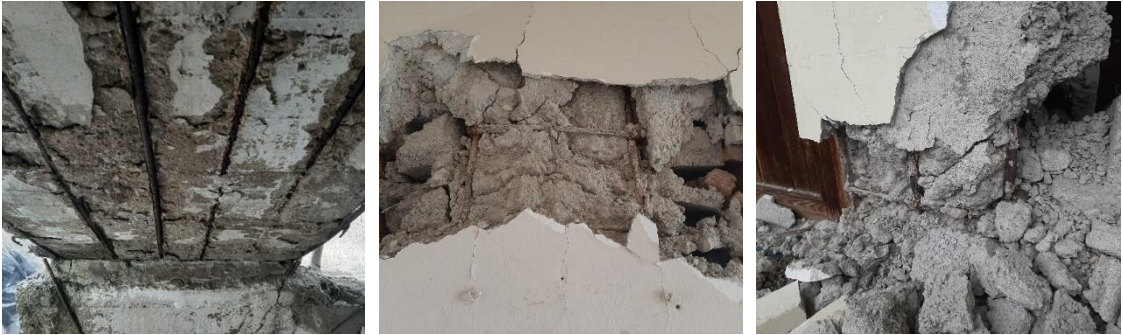
The main functions of the transverse reinforcement used in reinforced concrete structural elements, which create a wrapping effect, are to prevent buckling of the longitudinal reinforcements, to increase the ductility of the core concrete, and to meet the shear force. However, observations made after Düzce (Gölyaka) earthquake (November 23, 2022) showed that these requirements were not considered in some damaged reinforced concrete buildings (Fig. 20).

Fig. 20. Damages caused by insufficient transverse reinforcement

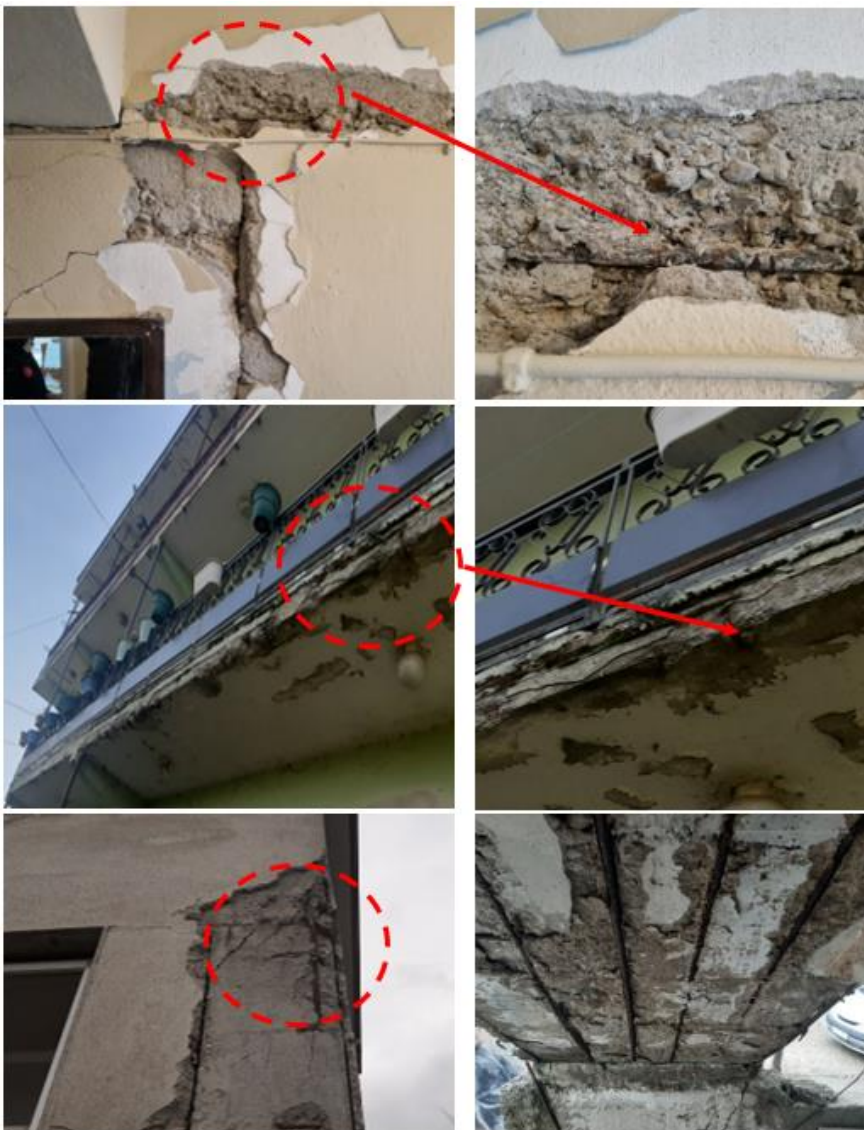
The adherence between concrete and construction steel enables reinforced concrete to be used as a composite building material. To increase the adherence between concrete and reinforcement, recesses are formed on the reinforcement at certain angles and ribbed reinforcements are produced. In Turkey, the use of unribbed reinforcement was allowed in TEC-1975, but the use of ribbed reinforcement was made mandatory in TEC-1998 [28,29]. Another factor that weakens the adherence between concrete and reinforcement is the corrosion of the reinforcement. Corrosion reduces both the cross-sectional area and bearing capacity of the reinforcement. Poor concrete quality, insufficient concrete cover, and lack of waterproofing in basements increase permeability, causing corrosion of the reinforcement and cracks or mass segregation in the concrete cover layer to parallel the reinforcements. In the site observations made after Düzce (Gölyaka) earthquake (November 23, 2022), it was observed that many reinforced concrete structures were damaged due to the use of unribbed reinforcement and corrosion (Fig. 21).

Fig. 21. Damages caused by corroded and unribbed reinforcement steels

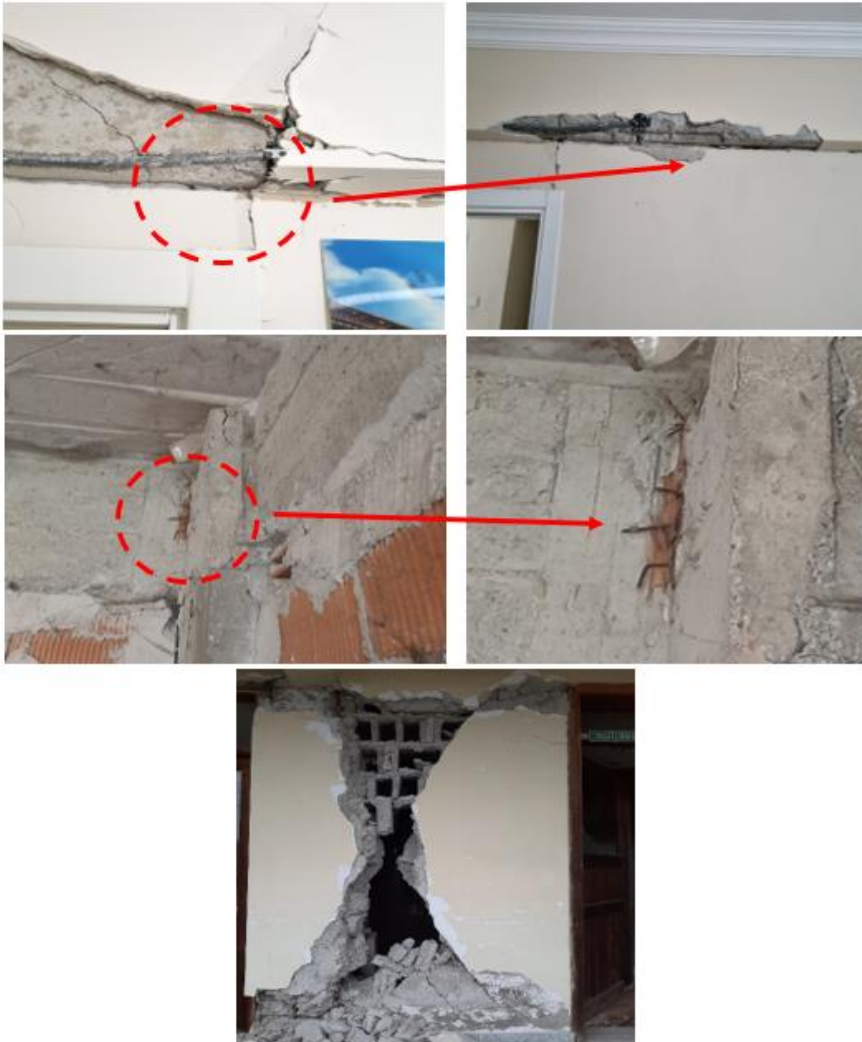
Even though RC buildings comply with guidelines and standards in terms of design, the workmanship in the construction phase is also very important. Poor workmanship and errors in the construction phase cause the buildings not to meet the expected performance (Fig. 22). To prevent damage caused by such mistakes, the construction phase of the buildings should be carried out carefully by qualified workers in accordance with the project.

Fig. 22. Damages caused by workmanship defects

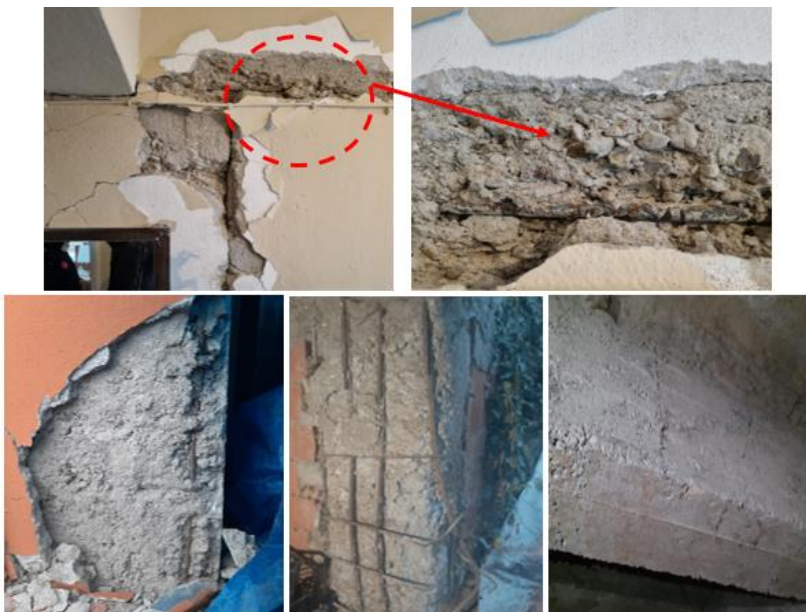
These factors lead to a significant decrease in concrete quality and the loss of homogeneous structure by separating the materials that make up the concrete. In the site observations made after Düzce (Gölyaka) earthquake (November 23, 2022), it was determined that the size distribution of the aggregates in the concrete used in the buildings was carelessly prepared and segregation occurred. Therefore, damages due to low concrete quality were observed (Fig. 23).

Fig. 23. Damages caused by poor concrete quality

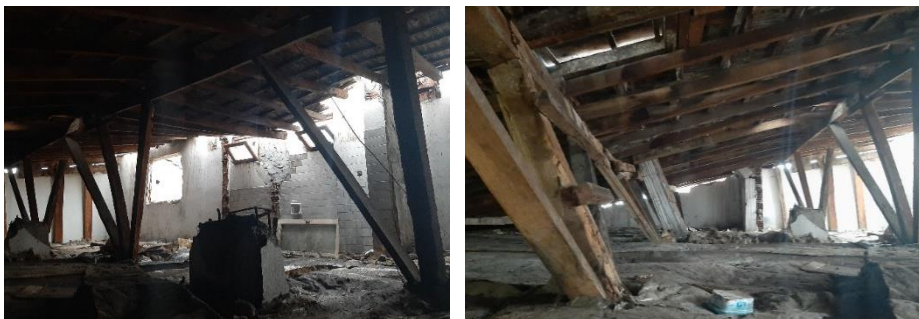
Another factor causing damage in RC buildings is weak gable walls. The garret attics of some RC buildings are covered with gable walls, usually with brick or briquette-like materials. In cases where these gable walls are not adequately enclosed, they can collapse under the effect of earthquakes and cause loss of life and damage (Fig. 24).

Fig. 24. Damages caused by the weak gable wall

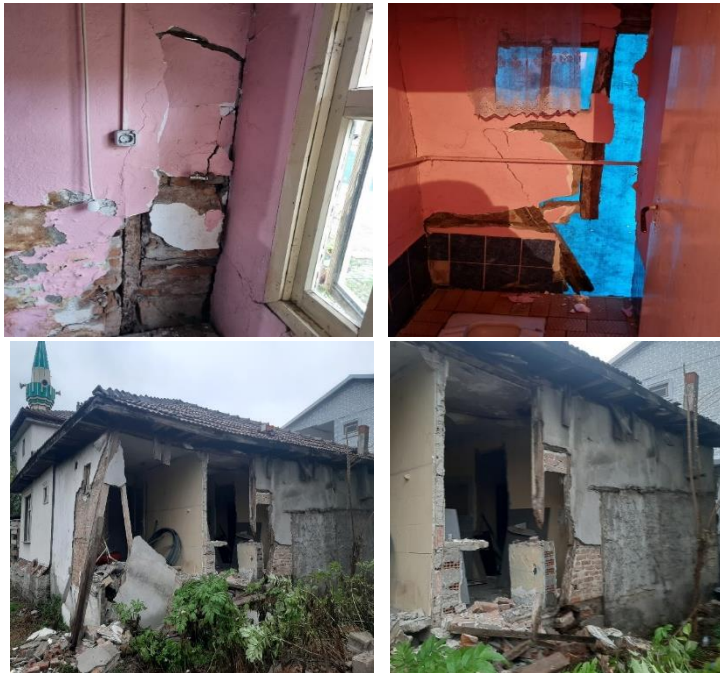
In masonry buildings, unsuitable connection details of the vertical walls may cause vertical or oblique cracks to occur and the wall units to separate from each other. In the site observations made after the earthquake, damages were detected in the connection sections of the vertical walls of the masonry buildings (Fig. 25). Other factors causing damage in masonry buildings are the unsuitable length of load-bearing walls (with and without reinforced concrete vertical beams) and any openings to be provided in load bearing walls (Fig. 26).

Fig. 25. Damages caused by unsuitable connection details of the vertical walls

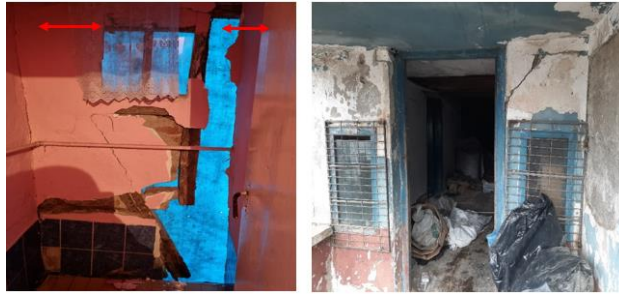
Fig. 26. Damages caused by unsuitable door and window openings

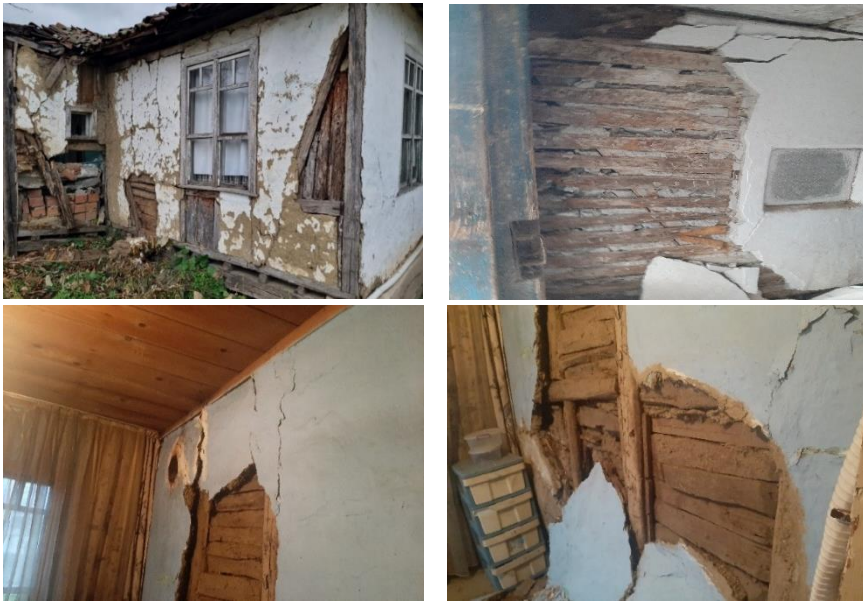
Fig. 27. Vertical crack damage in low-strength adobe units

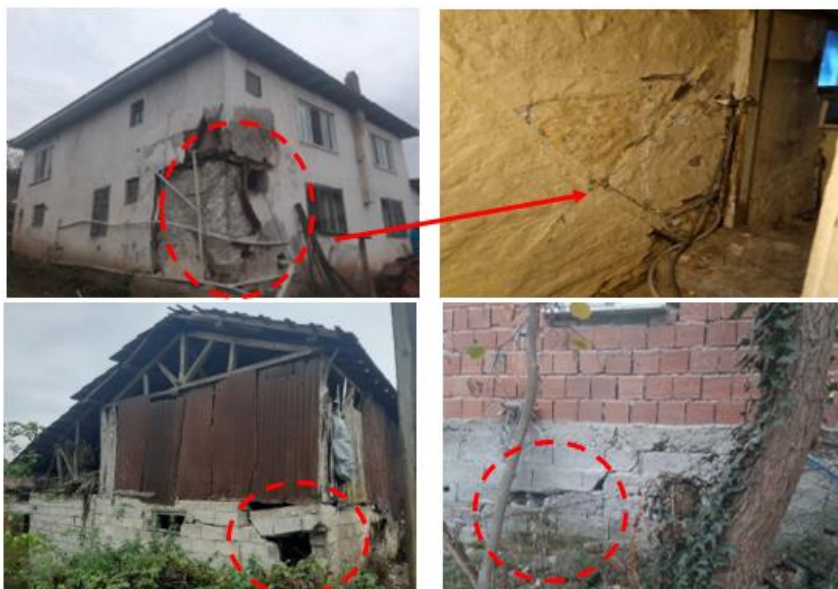
Fig. 28. Vertical crack damage in low-strength masonry units

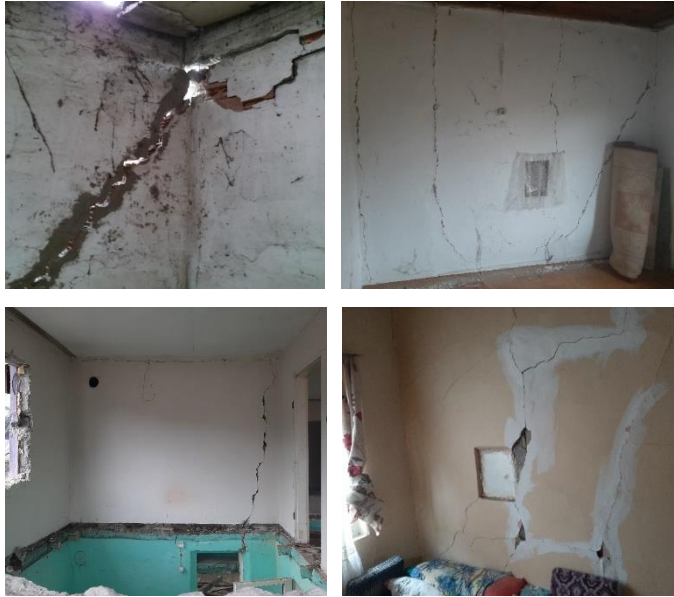
It is widely acknowledged that the degree of adhesion between the mortar and the masonry units affects the shear strength of masonry walls. Low-strength adobe and masonry units reduce the strength of such masonry walls and make them vulnerable to earthquake effects (Fig. 27 and Fig. 28). Also, shear cracks in load-bearing masonry walls typically form as a straight crack and diagonal tension cracks along the bearing joint. These cracks can occur due to various reasons such as unqualified workmanship, poor material properties, a large window or door openings, insufficient locking between wall units, etc. (Fig. 29).

Fig. 29. Wall damages

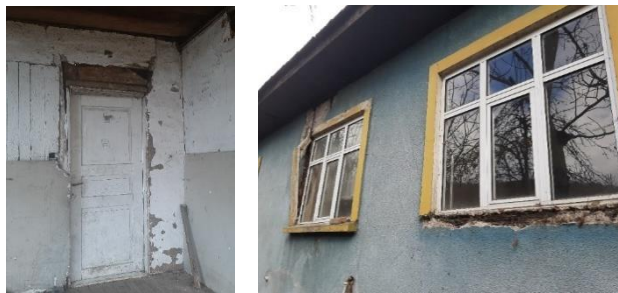
The lintel is formed by lining up the materials such as solid wood, stone, etc. by the gap edges. In case of missing or insufficient length of the lintel, serious damage may occur in the corners of windows and doors in masonry buildings. It was observed that damages were caused by the insufficient length of the lintel in the site observations (Fig. 30).

Fig. 30. Damage occurred due to insufficient lintel length

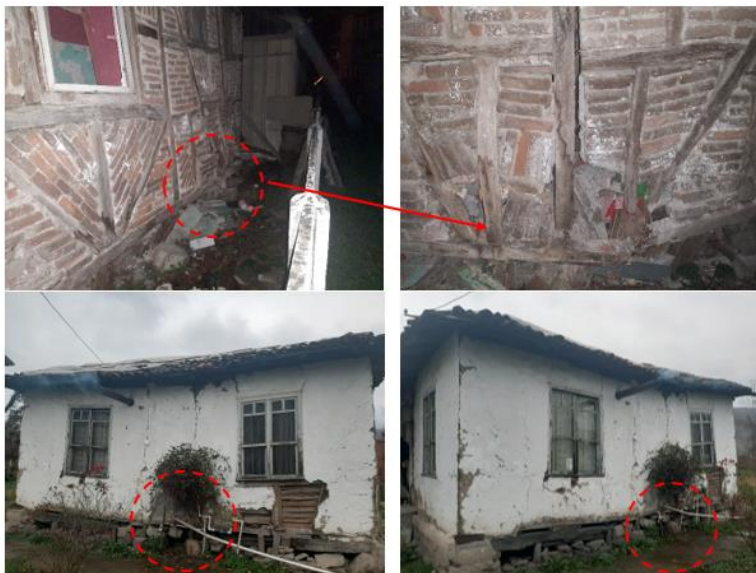
One of the causes of damage in masonry buildings can be considered as errors in foundation design and different foundation settlements. Masonry buildings can easily be damaged or even collapse due to the slightest foundation problem. In the site observations made after the November 23, 2022, Düzce (Gölyaka) earthquake, heavily damaged masonry buildings due to foundation damage were detected (Fig. 31). In these buildings, the bottom of horizontal supports, which serve as the foundation, was emptied and damaged by the earthquake. Therefore, the buildings were damaged due to settlement.

Fig. 31. Damages caused by foundation movement

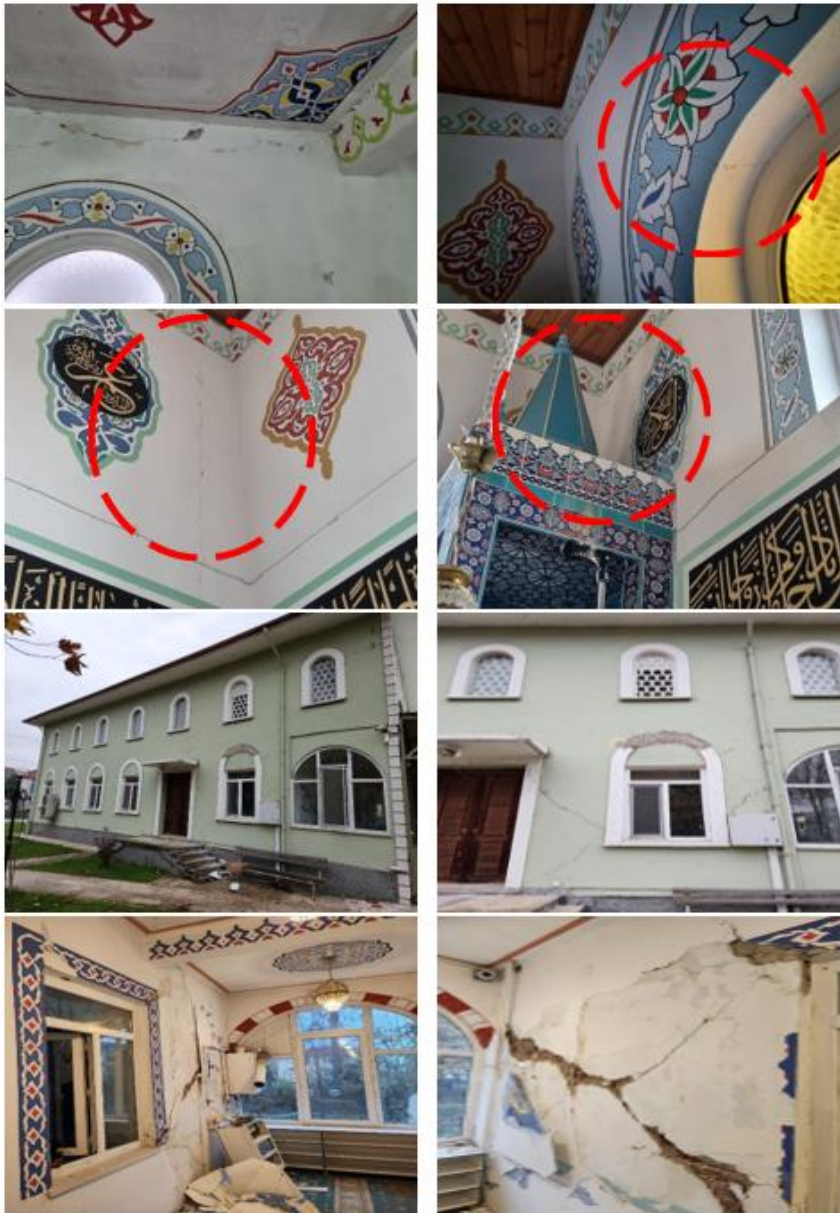
Structural damages were detected in many RC and masonry mosques in the site observations made after Düzce (Gölyaka) earthquake (November 23, 2022) (Fig. 32). These observed damages can be classified as follows: (i) columns, beams, shears, etc. Structural cracks and articulation in the carrier system elements, (ii) column-beam junction damage, (iii) openings in the dome drum, (iv) damage to the side vaults on which the domes sit, (v) minaret damage, (vi) inadequate material quality, (vii) cracks around the cavity on the walls, (viii) floor deflections, (ix) lack of reinforcement detailing, (x) damages due to previous earthquake history.

Fig. 32. Damages observed in (a) reinforced concrete and (b) masonry mosques
