RESEARCH ARTICLE

On the earthquake-related damages of civil engineering structures within the areas impacted by Kahramanmaraş earthquakes

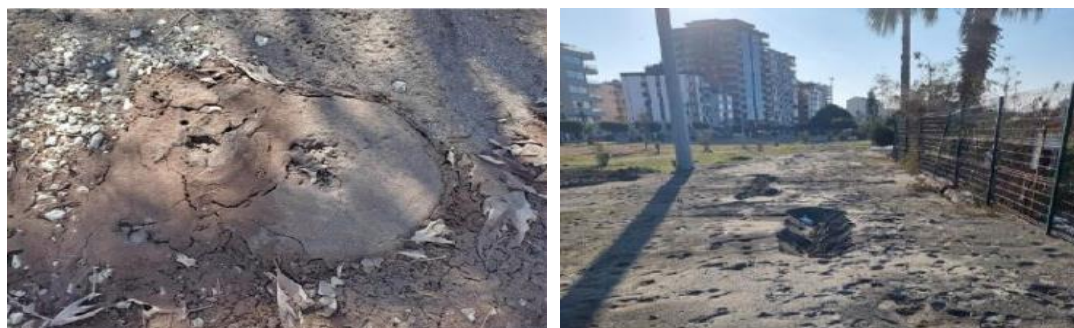
After the Kahramanmaraş earthquakes, typical damages due to soil liquefaction were observed widely in Gölbashi in Adıyaman and İskenderun in Hatay. Sand cones formed in Adıyaman and İskenderun as a result

of soil liquefaction are given in Fig. 4. When the soil problems occurring in these districts are examined on site, it has been determined that the common defect in Gölbaşı is not liquefaction, but the loss of bearing capacity. In terms of the formation of this district, the lake sedimentation symbolizes the dominance of soft clays in the region. Soft clays tend to soften rather than liquefy under dynamic effects. As a result, it is understood that the dominance of the situation that causes the excessive deformation of these buildings in Gölbaşı is not in liquefaction, but in the loss of bearing capacity of soft clays under dynamic loads. Uniformly seated, differentially seated, and overturned buildings occurring in Gölbaşı buildings are seen in Fig. 5.

Adıyaman - Gölbaşı

Hatay - İskenderun

Fig. 4. Sand cones formed in Adıyaman and İskenderun as a result of soil liquefaction

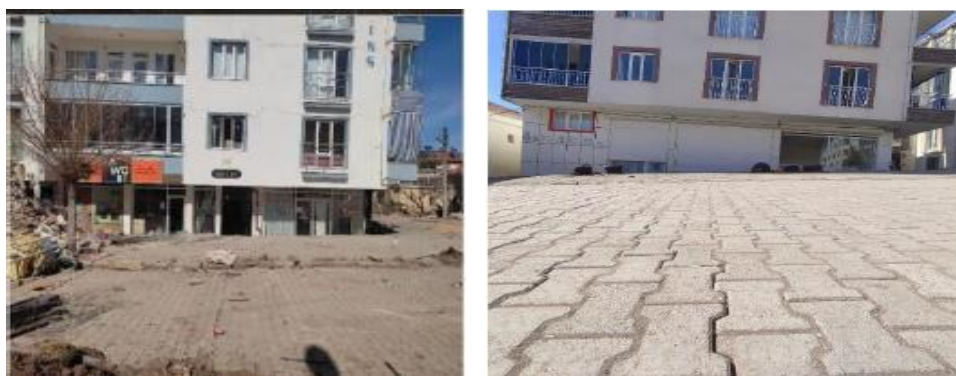
Uniform settlement

Non-uniform settlement

Fig. 5. Sand cones formed in Adıyaman and İskenderun as a result of soil liquefaction

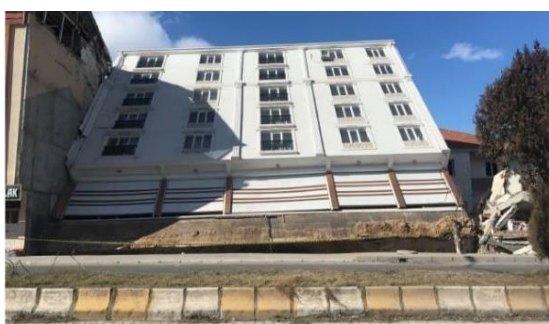
Overturn

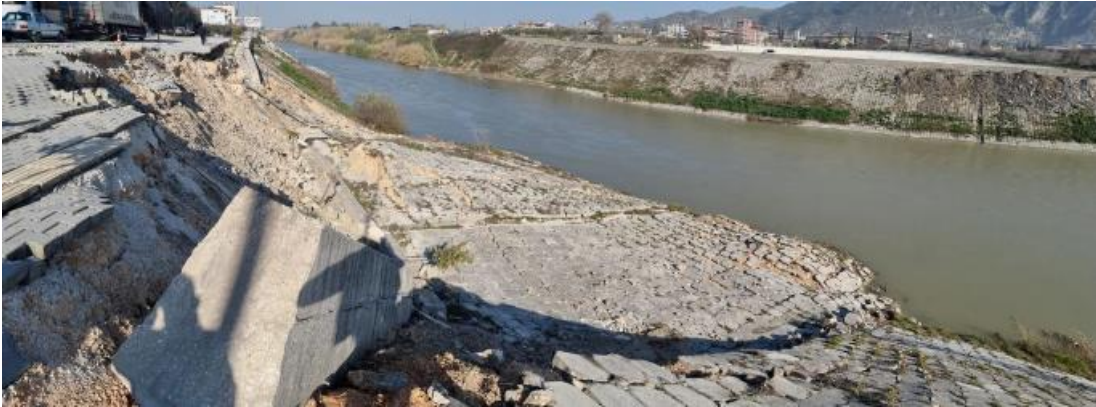
Another ground-based damage type experienced after the 6 February 2023 earthquakes is mass movements. Mass movements are defined as processes of erosion, transport, and accumulation of material that occur on both gentle and steep slopes mainly owing to gravitational forces. The mass movements occurred in Hatay and the rock falls on the Gaziantep İslâhiye Kökçü road are shown in Fig. 6.

Mass movement in Hatay

Fig. 6. Mass movement and rock fall

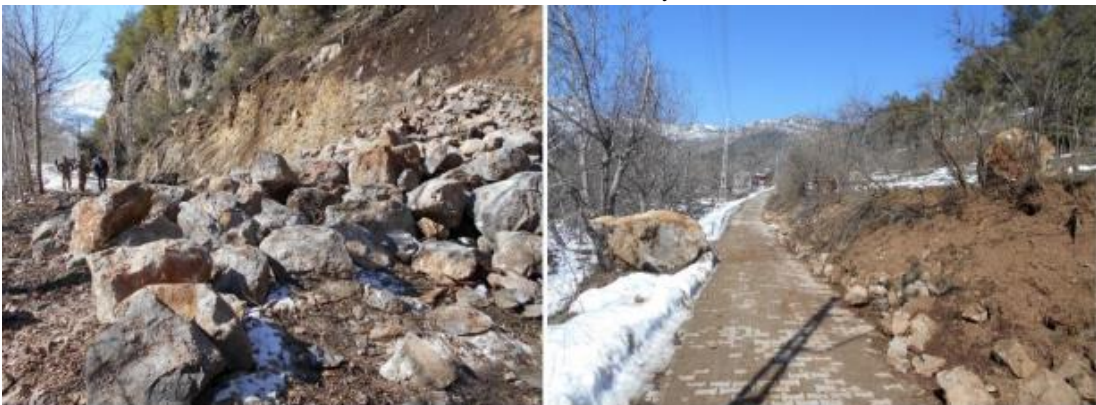
Rockfall in Gaziantep

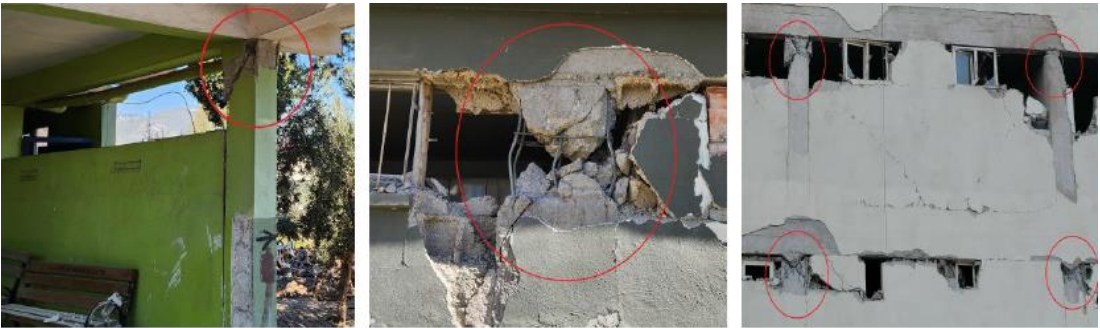
The spaces left for lighting and ventilation in the infill walls of the buildings or the half walls made in the ground and basement floors play an important role in the formation of short columns. Since the short columns formed have high rigidity and low ductility, they are damaged by shear fracture if necessary precautions are not taken under horizontal displacements. Structural damages due to short column formation were determined in field observations (Fig. 7). Column-beam connection points of RC structures are exposed to great forces under the effect of earthquakes. Excessive stresses in these regions cause structural damage. As a result of the field observations made in the earthquake zone, the damages in the column-beam regions were observed (Fig. 8). If the overlapping length of the reinforcements is insufficient, the seismic performance of RC buildings is adversely affected. To avoid such problems, it is necessary to comply with the conditions in the codes. Details of damage due to insufficient overlap length observed are given in Fig. 9.

Fig. 7. Structural damage from short column formation

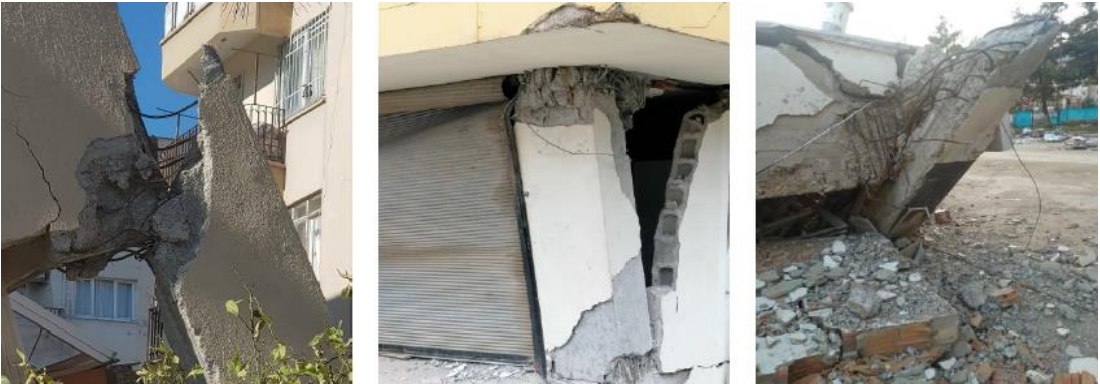
Fig. 8. Column-beam connection failures

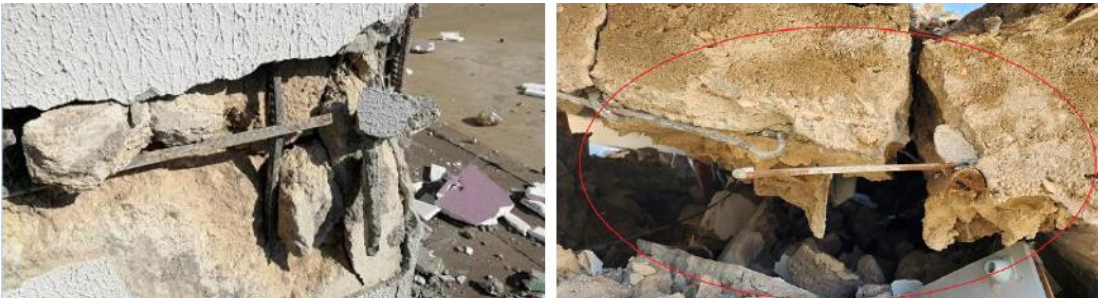
Fig. 9. Existence of short and unconfined lap splices

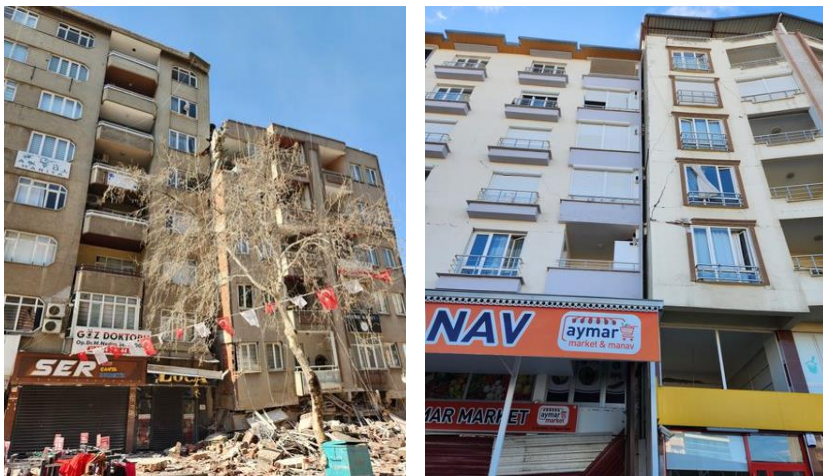
Adjacent structuring is frequently encountered in Türkiye. However, if there is not enough space between these structures, horizontal movements of buildings can have destructive effects on each other (Fig. 10). The transverse reinforcements used in RC structural elements have main functions such as preventing buckling of the longitudinal reinforcements, increasing the ductility of the core concrete, increasing the compressive strength of the core concrete and meeting the shear forces. As a result of the field observations made in the earthquake zone, it was observed that the requirements given in the codes were not taken into account in the selection and placement of the transverse reinforcements, and the damages that occurred due to this reason are given in Fig. 11. A floor system consisting of evenly spaced shallow beams and a thin plate is called rib flooring. In rib flooring systems, a hollow floor system is obtained by filling the gaps between shallow beams with non-bearing building materials. They are preferred due to the reduction in mold and plaster workmanship, and the architectural advantages that allow economical and fast production. This type of flooring creates problems in terms of beam-column connection performance (Fig 12). In TBEC-2018, situations that cause irregularity in buildings are defined under two headings as irregularities in the plan and the vertical direction. Irregularities in the plan are classified as torsional irregularity (A1), slab discontinuities (A2), and projections in plan (A3), while the weak story (B1), soft story (B2) and discontinuity of the vertical elements of the carrier system (B3) are classified as vertical irregularities. The weak story damages observed in field investigation are shown in Fig.13

Fig. 10. Inadequate safe distance

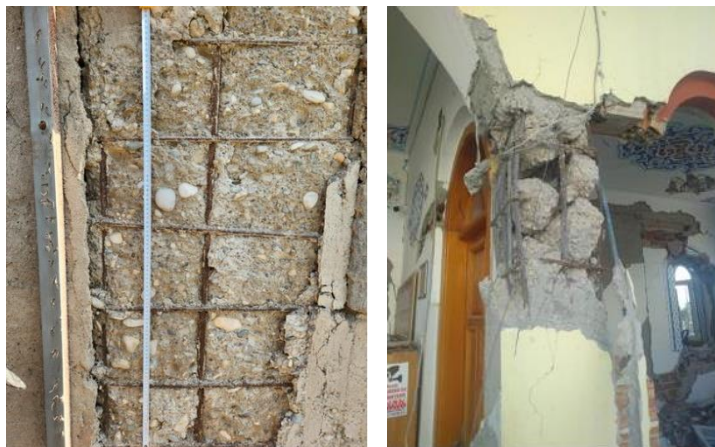
Fig. 11. Insufficient transverse reinforcement

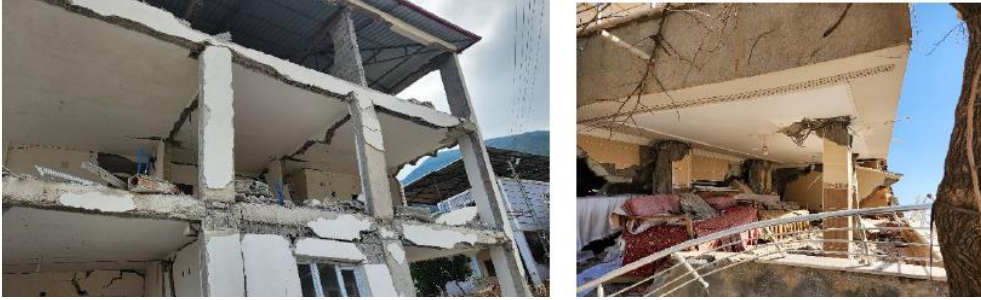
Fig. 12. Damages caused by hollow flooring application

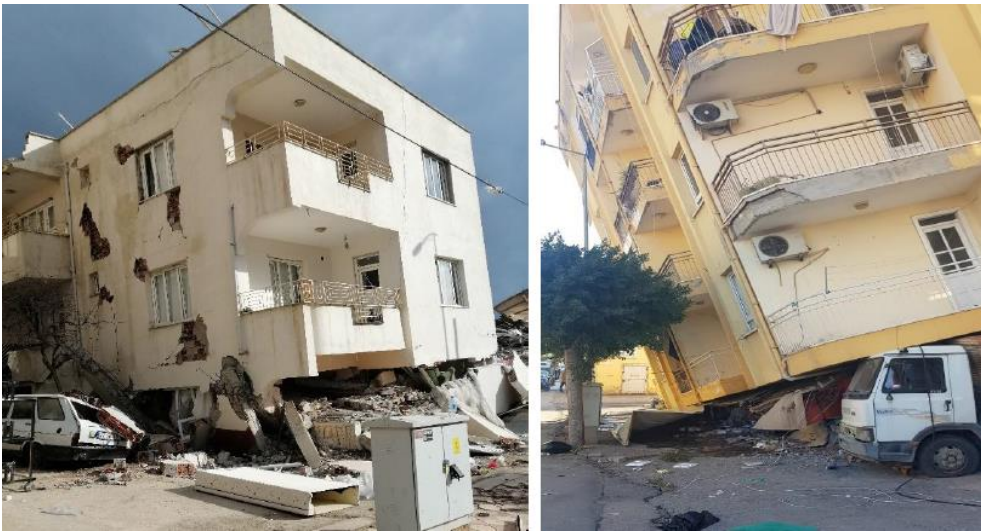
Fig. 13. Soft story damages

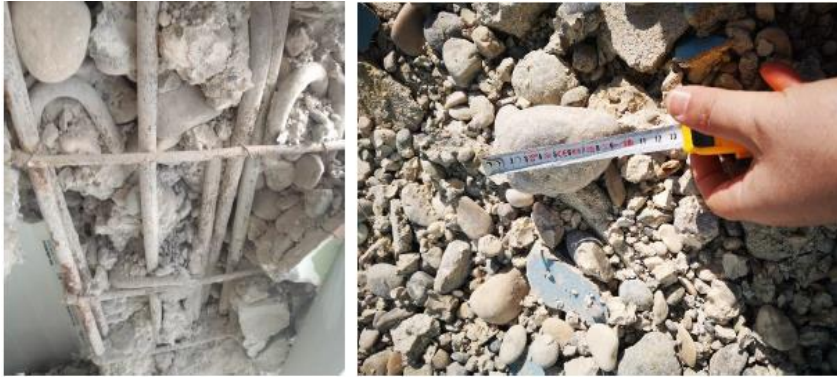
One of the biggest factors causing damage and destruction to structures in past earthquakes in Türkiye is the low concrete quality (Fig. 14). For this reason, it is seen that the quality of concrete is gradually increasing in the codes that came into force in the following years. In TBEC-2018, which is currently in force, the minimum characteristic strength of the concrete was determined as 25 MPa. For RC, to show the expected behavior, adherence must be formed between the concrete and the reinforcements that make it up. In particular, to increase adherence ribbed reinforcements are produced. The combination of non-ribbed reinforcement and poor quality concrete causes weaker adherence formation and adversely affects the behavior of RC (Fig. 15). Incorrect placing of reinforcement bar, incorrect end hook angle and length, and weak gable walls can be defined as workmanship defects. The damages caused by workmanship defects are given in Fig. 16.

Fig. 14. Poor concrete quality

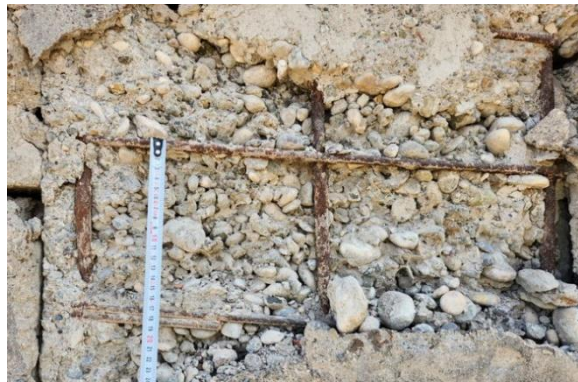
Fig. 15. Unribbed reinforcing bar and corrosion

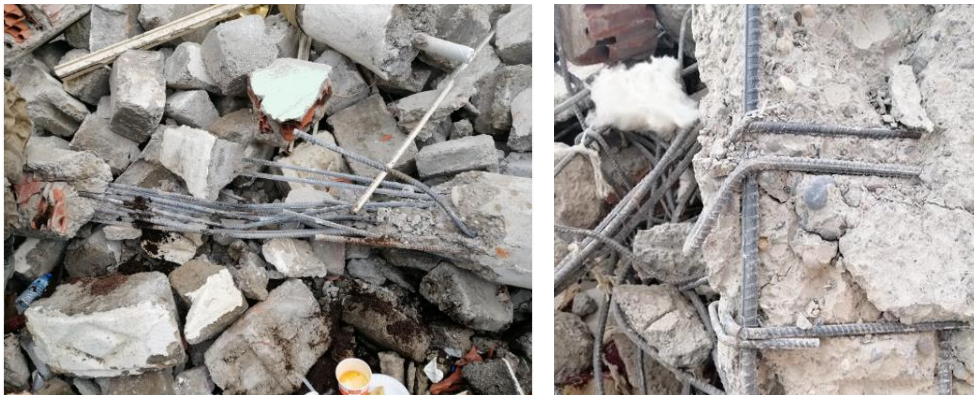
The incorrect placing of the reinforcement bar

Incorrect end hook angle and length

Fig. 16. The workmanship defects

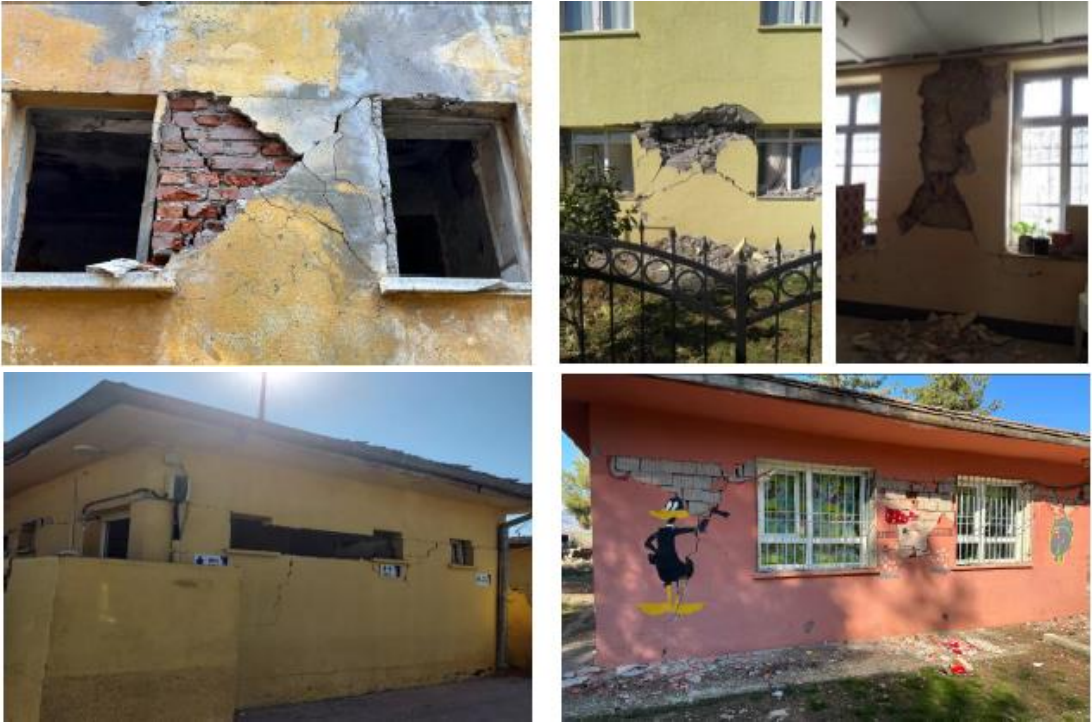
The masonry construction technique is a construction method that is frequently used in different parts of the world and dates back centuries. Masonry buildings constitute a substantial part of the building stock in Türkiye. This ratio increases from the city to the countryside. In masonry buildings, almost all walls are load-bearing elements. Earthquake forces create in-plane and out-of-plane effects on these walls. In-plane (Figure 17) and out-of-plane (Figure 18) damage and/or collapse mechanisms occur on the walls due to these effects.

Fig. 17. In-plane damages on masonry buildings

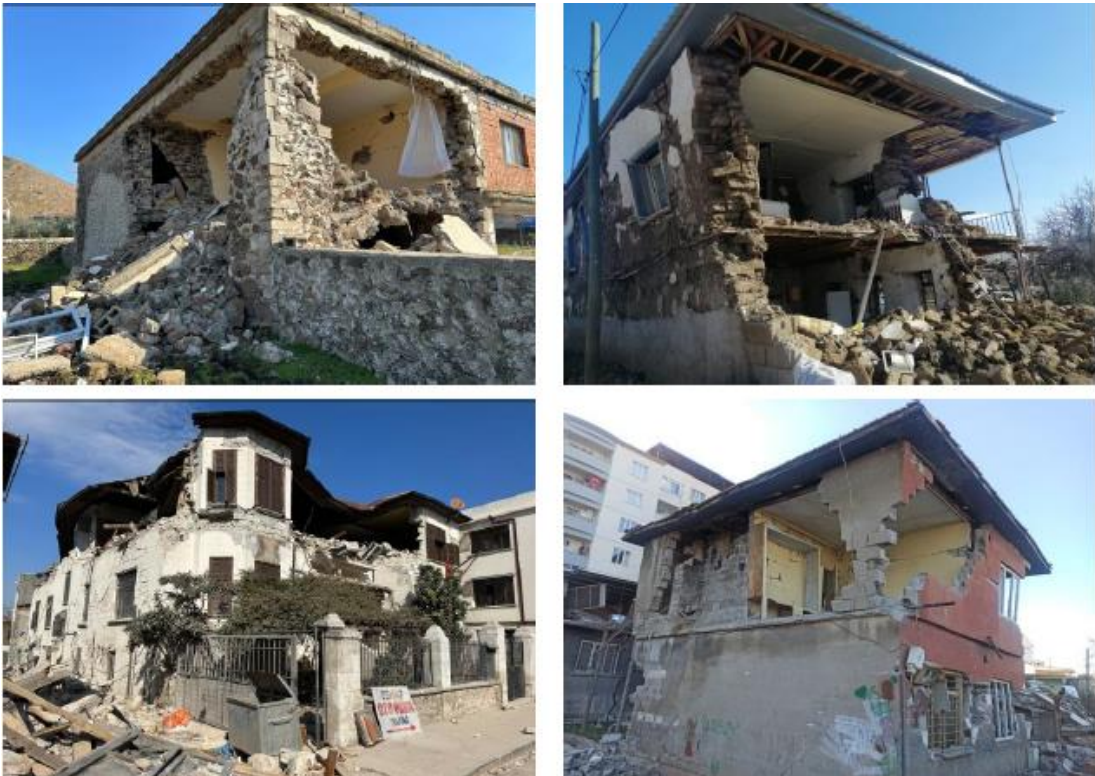
Fig. 18. Out-plane damages on masonry buildings

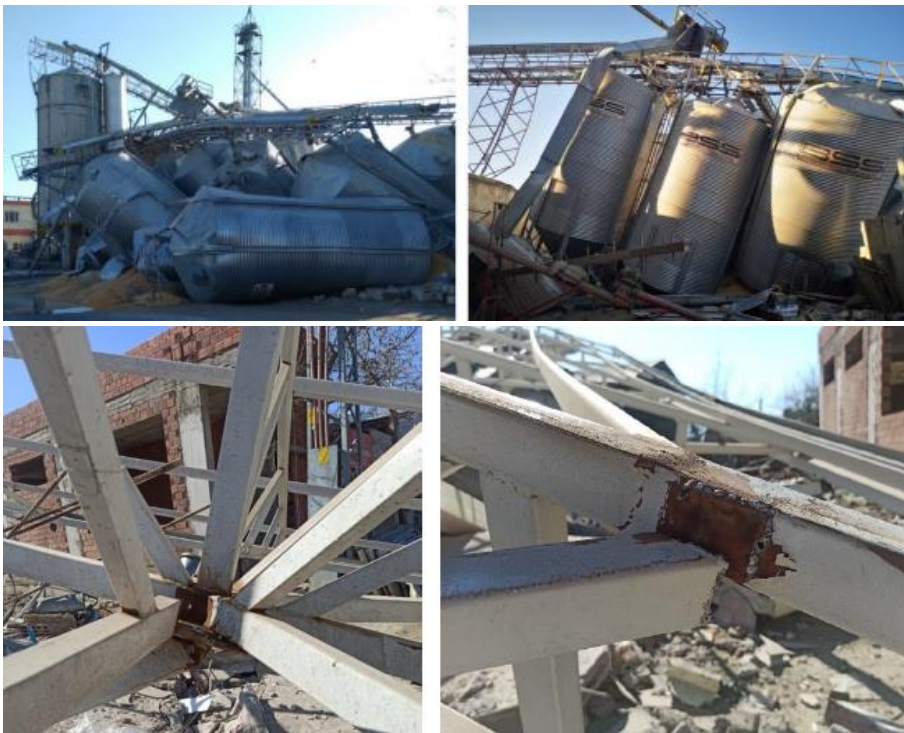
Fig. 19. The damages on steel industrial structures

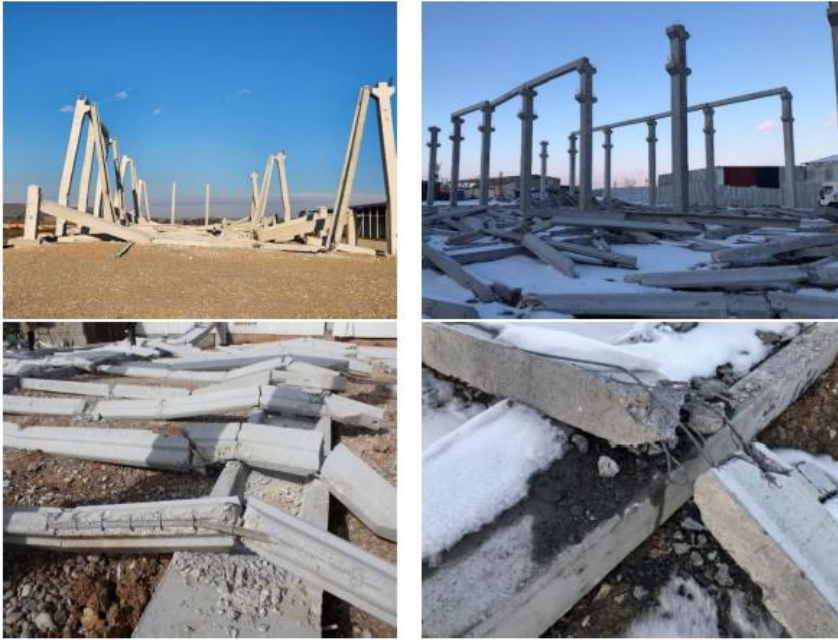
Industrial buildings in the earthquake zone generally consist of prefabricated reinforced concrete systems, a small number of steel carrier systems, and small industrial structures consisting of classical reinforced concrete frame systems. In the field observation, it is seen that the majority of reinforced concrete prefabricated factories have structural damage, and a lower rate of damage occurs in a small number of steel-constructed industrial structures. Steel structures can be damaged in earthquakes due to application and design errors and not receiving adequate engineering services (Fig. 19). In prefabricated industrial structures, load transfer cannot be completed in the system because the columns on the roof are not connected with sufficient rigid elements. They are connected with articulated purlins and a rigid diaphragm is not formed. Roof beams are placed perpendicular to the long direction in industrial buildings and are supported by pin connections to the columns. Similarly, purlin beams are articulated to the roof beams with very weak pins. For these reasons, damages occurred to the roof and purlin beams (Fig. 20).

Fig. 20. The damages on steel industrial structures

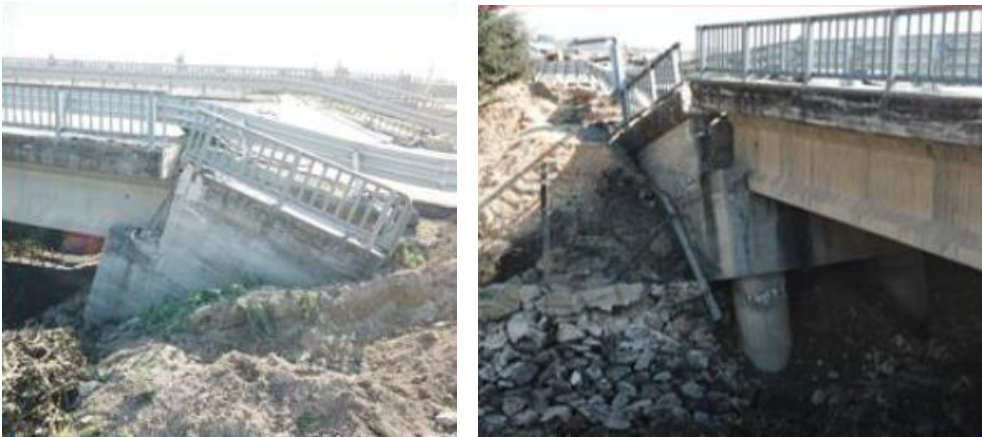
Bridges and viaducts are indispensable elements for transportation systems. Bridges play an important role, especially in areas such as providing transportation to the areas where destruction took place after earthquakes, the transmission of aid elements, and the evacuation of people. Commonly encountered damages in earthquakes can be listed under three headings as ground-foundation damages (Fig. 21), infrastructure damages, and joint and support damages (Fig. 22).

Fig. 21. Ground-foundation damages

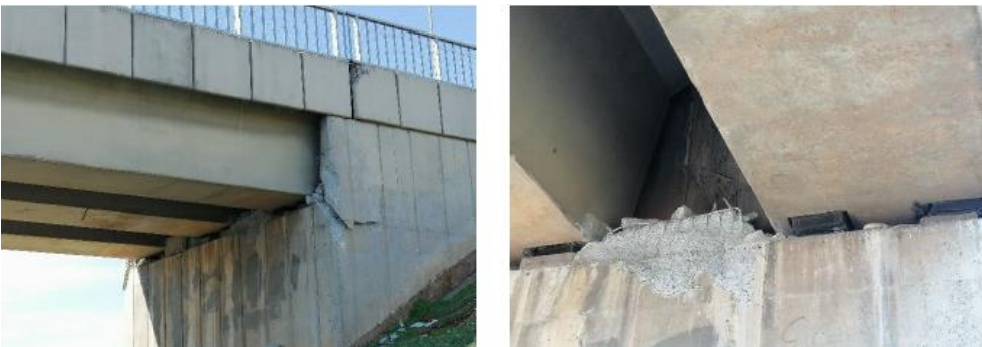
Fig. 22. The joint and support damages

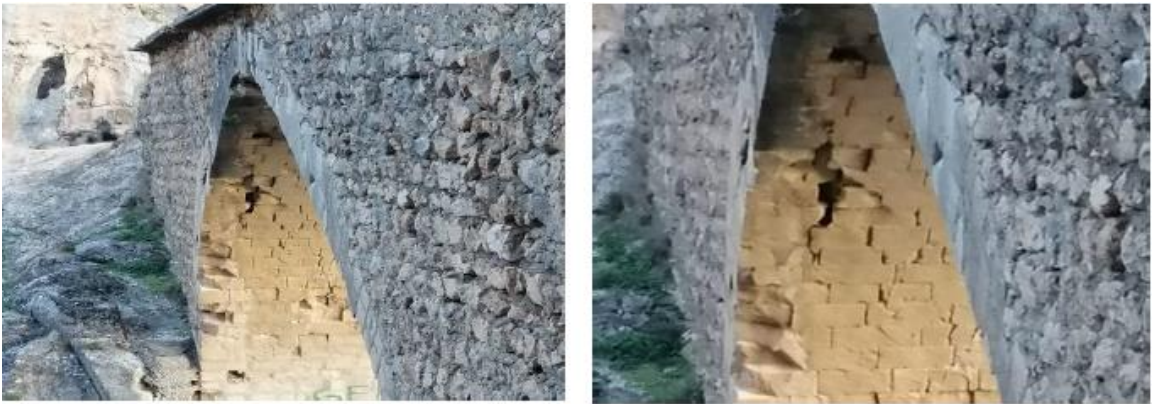
As a result of the investigations carried out in the region, no structural damage was detected in some masonry bridges, some of them were slightly damaged, while others were severely damaged. Devil (Memluk) Bridge located in Kahta District of Adyaman separation and fractures were observed in the arch stones of the bridge. In the examination carried out in Hatay, it was determined that some of the spandrel walls of the bridge had completely collapsed and some had obvious cracks (Fig. 24).

Fig. 23. Damages observed on Devil (Memluk) Bridge

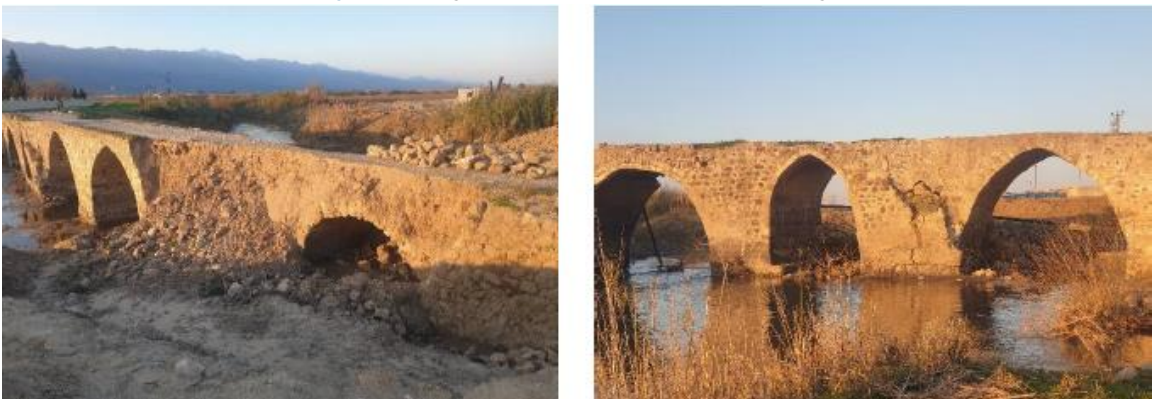
Fig. 24. Observed collapsed and cracks of the spandrel wall

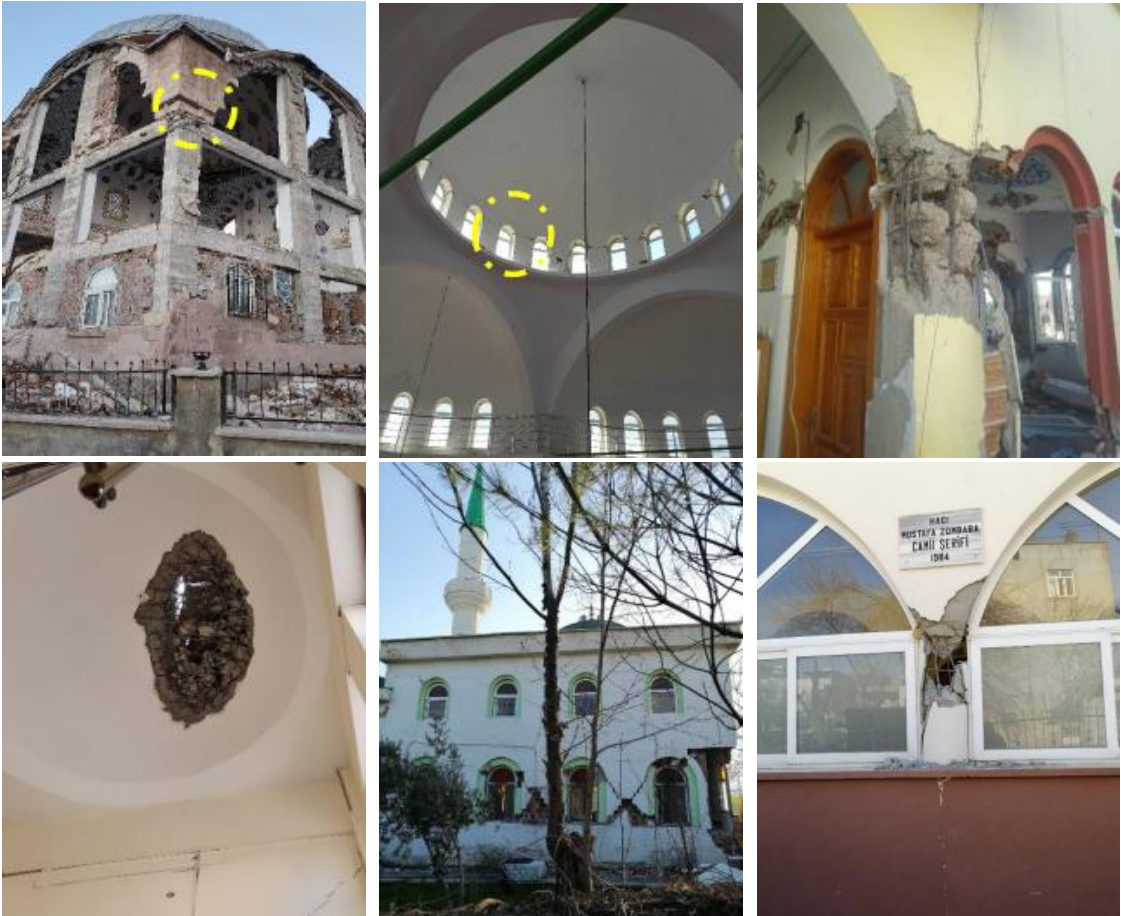
Fig. 25. Observed damages on reinforced concrete mosques

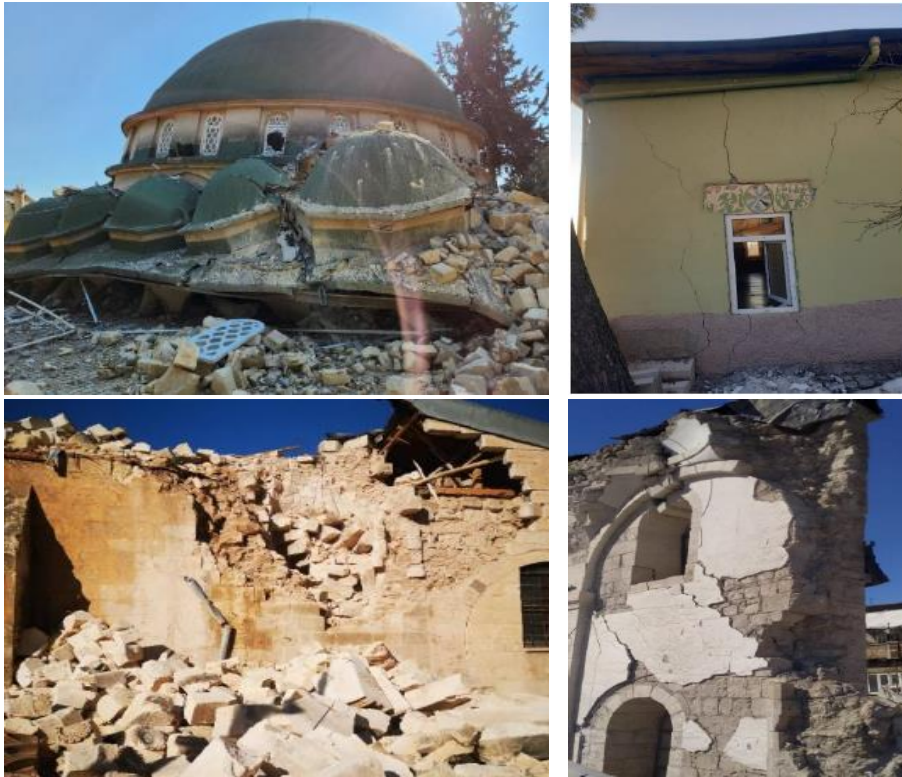
Fig. 26. Observed damages on masonry mosques

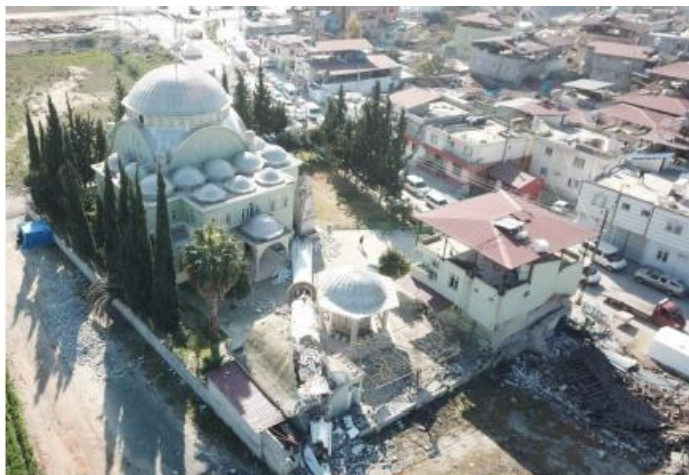
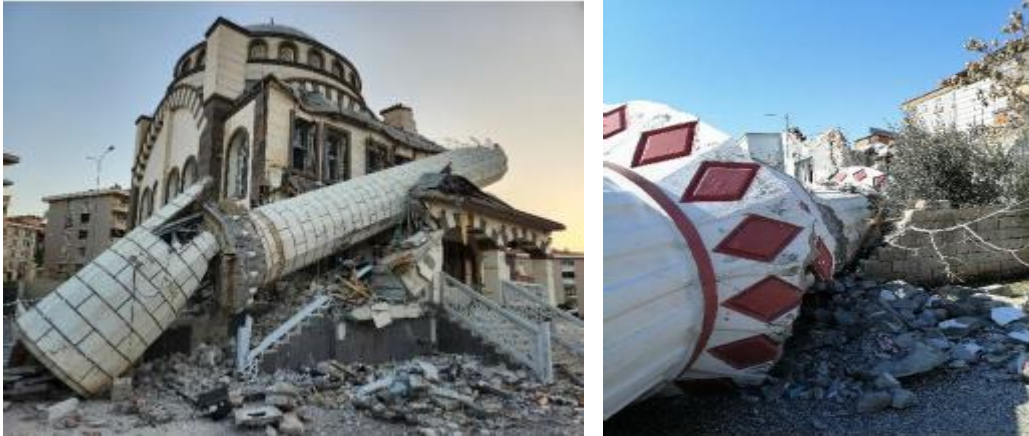
Many mosques have been built with different materials, construction techniques, and architectural styles throughout history. The carrier system of many mosques consists of similar elements. The main basic structural elements of the carrier system in mosques are listed as domes, arches, vaults, pillars, and columns. It has been observed that in the mosques built with reinforced concrete and masonry technique, damages are similar to those mentioned in building-type structures in the above sections. The damages observed on RC and masonry mosques are shown in Fig. 25 and Fig. 26, respectively. Most of the mosques in Türkiye have minarets and there is no regulation in force regarding the design of these structures. This situation causes these structures to be built without technical requirements and restrictions, and to be damaged or even completely collapsed under dynamic loads such as wind and earthquake. The demolition of minarets causes damage to mosques and nearby structures and even loss of life. The damages observed on RC and masonry minarets are shown in Fig. 27 and Fig. 28, respectively.

Fig. 27. Observed damages on reinforced concrete minarets

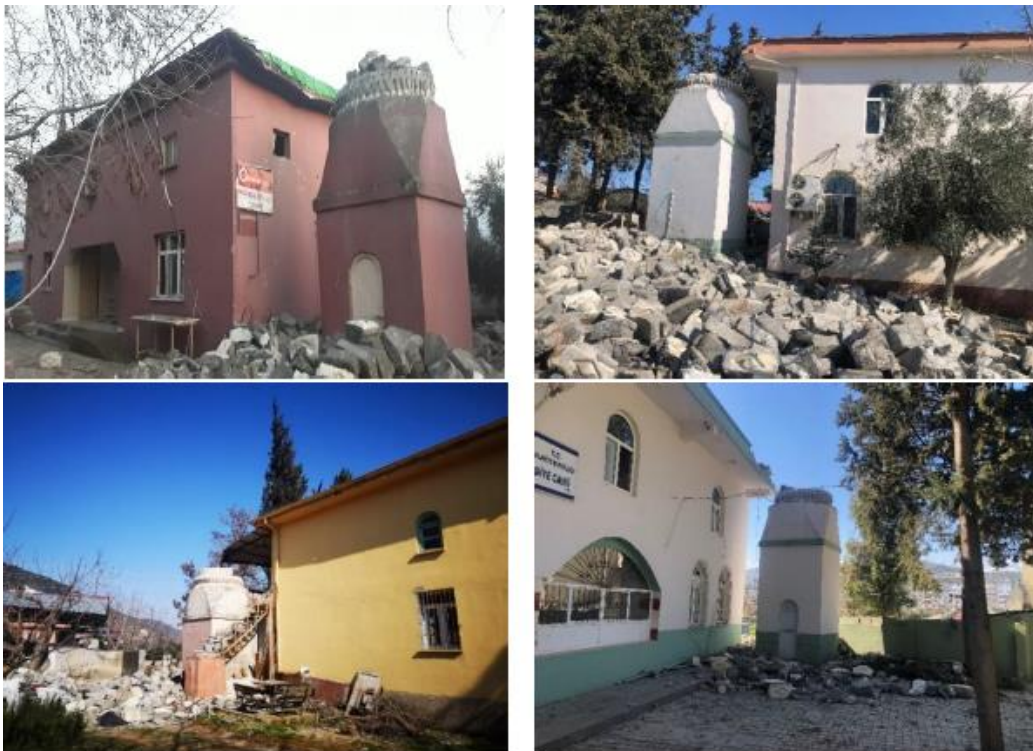
Fig. 28. Observed damages on reinforced masonry minarets
