RESEARCH ARTICLE

Seismic damage assessment based on site observation following the Düzce (Gölyaka) earthquake ($M_w = 5.9$, November 23, 2022)

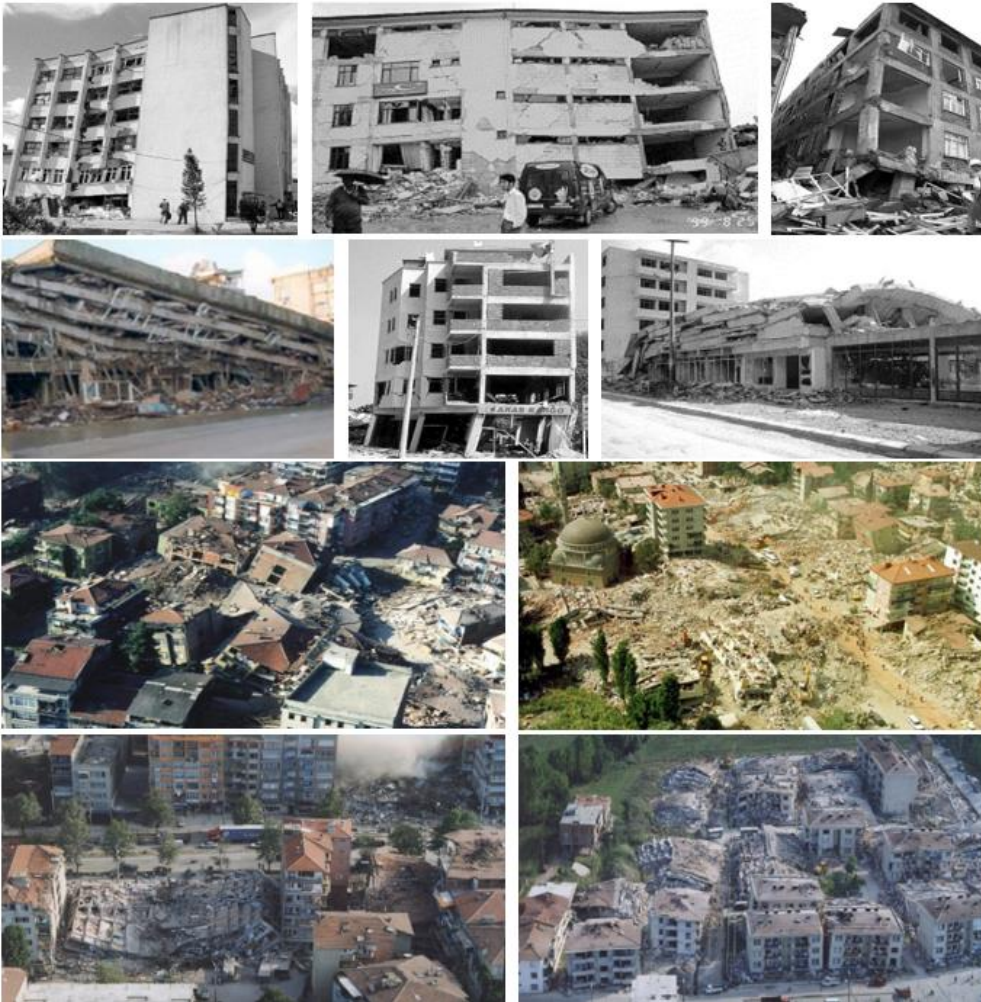
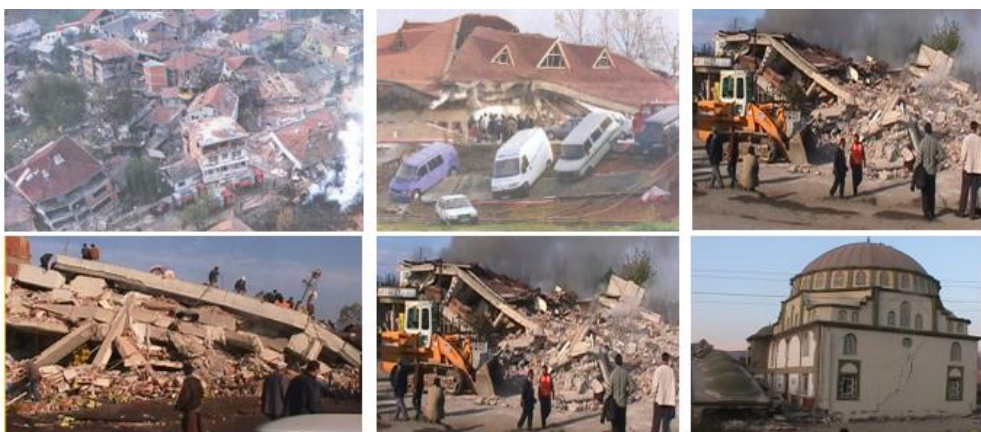
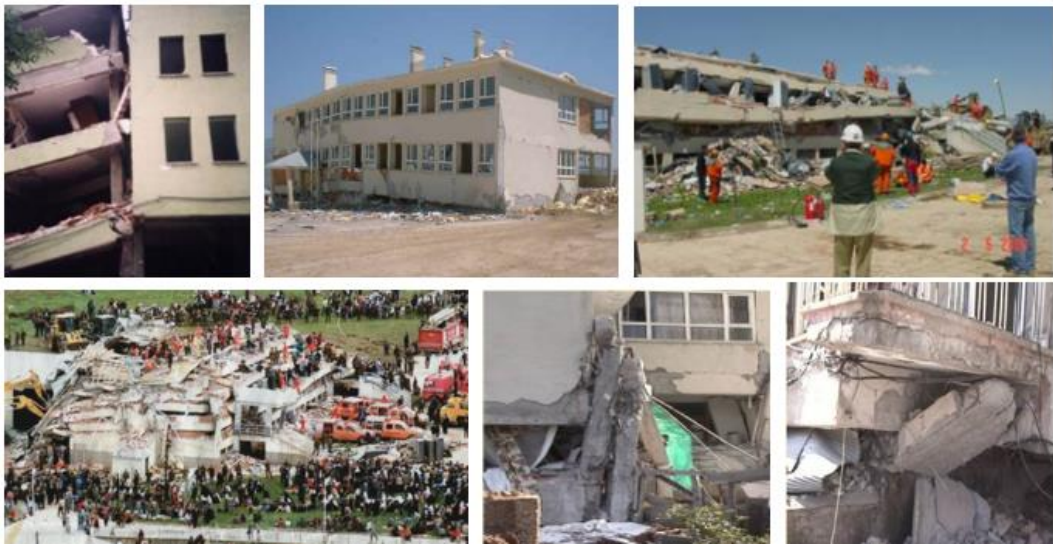
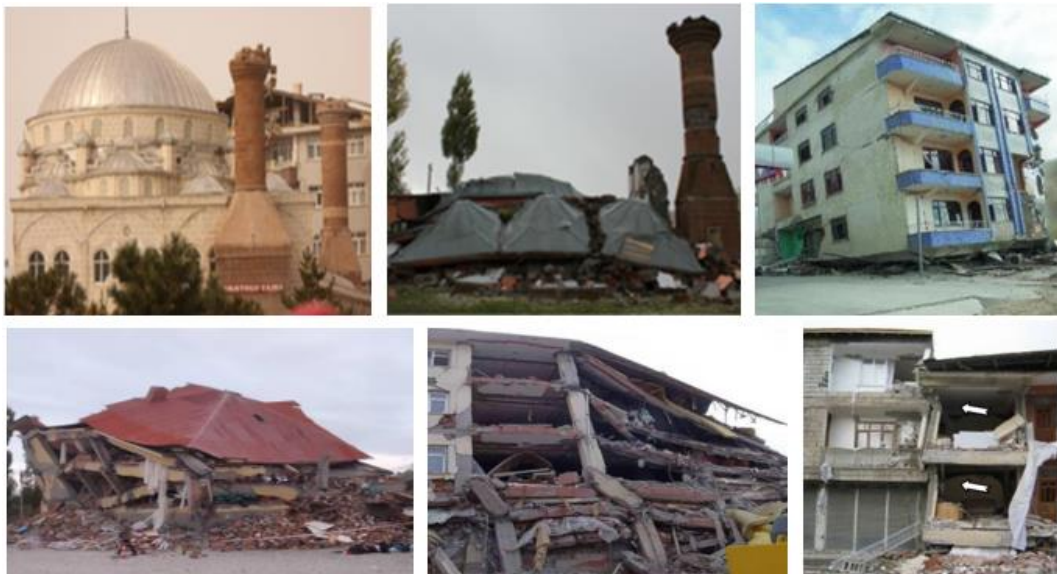
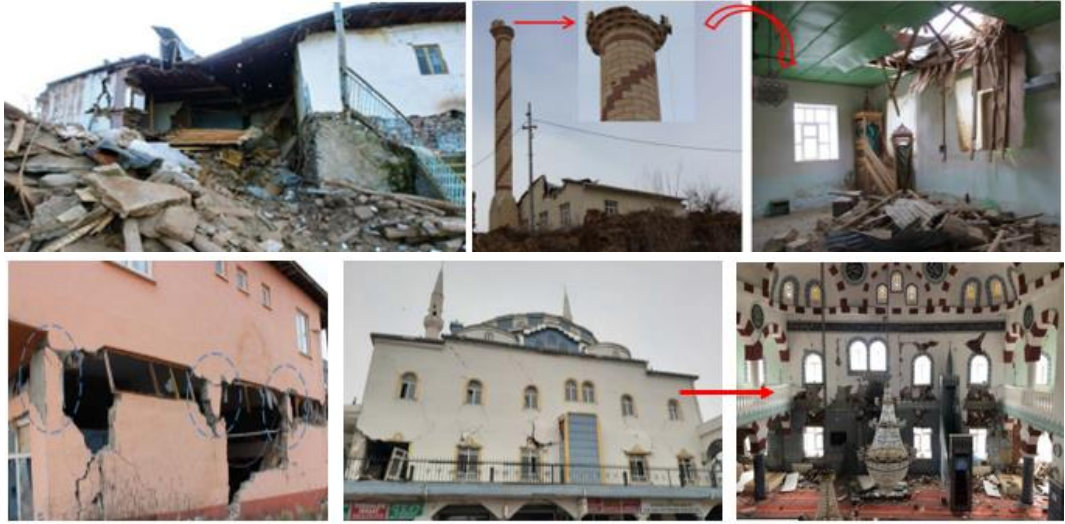
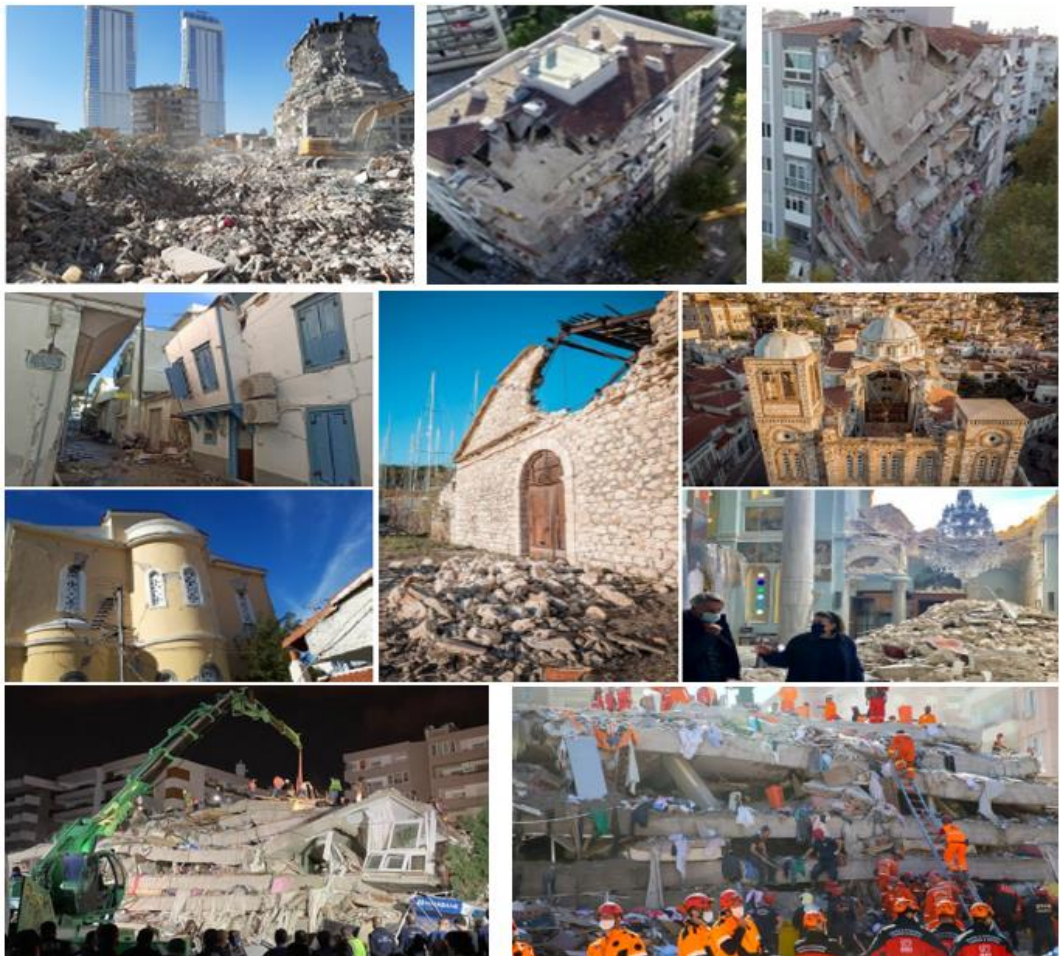
earthquake ($M_L = 5.3$), 2011 Van ($M_w = 7.1$), 2019 İstanbul ($M_w = 5.7$), 2020 Elazığ ($M_w = 6.8$), 2020 Aegean Sea ($M_w = 6.9$) earthquakes, etc. have occurred on the NAF, EAF and WAF [1]. In addition to the loss of life, heavy structural damages and collapse occurred in a significant part of the building stock in earthquakes with such devastating effects that occurred in Turkey (Fig. 4).

Fig. 4. Examples of damaged and collapsed reinforced concrete and masonry structures during recent earthquakes in Turkey
